## Experimental analysis of strain of blast furnaces shell during the start up to

<sup>b</sup>Blast Furnace Engineering and technology Europe, U.S.Steel Košice, Slovakia

Circumferential BF hearth shell stress was measured during the two blast furnaces blow-in periods. BF1 had the hearth with not developed salamander. It was blew down after relined and few days of full tuyeres operation. BF3 hearth had fully developed salamander after 12 years of operation. Before start up both BF hearths were identical cleaned up 1 m below the tap hole elevation. Blow in line on BF1 also BF3 salamander were circumferential trenched out up to the hearth bottom elevation down. Maximal measured BF1 hearth shell tension level reached

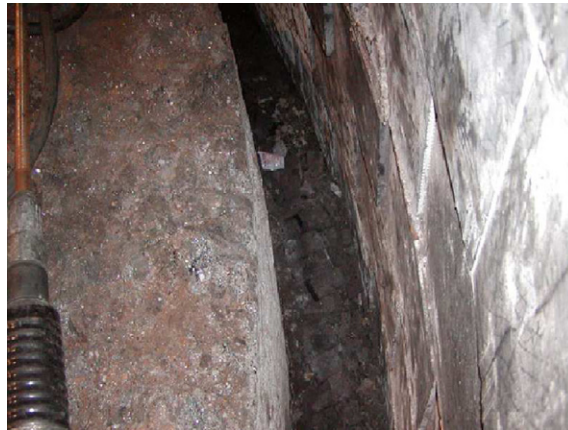
BF1 after reline was emergency shut down 5 days after blow in due to gas cleaning system failure. During the 50 days of unplanned outage a portal was opened above the tap hole #1 to clean up coke and ore from the stack and hearth. Hearth was cleaned up 1 m bellow tap hole elevation and circumferential old blow in line was trenched out as visible from the figure 1.

Fig. 1 Trenched blow-in line on BF1 up to the hearth bottom.

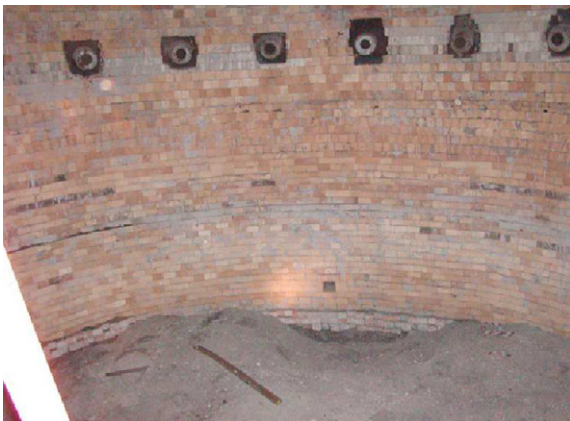
Gap was filled by coke breeze and new blow-in line was re-build as figures 2, and 3 present.

Fig. 2 BF1 hearth view before coke fill

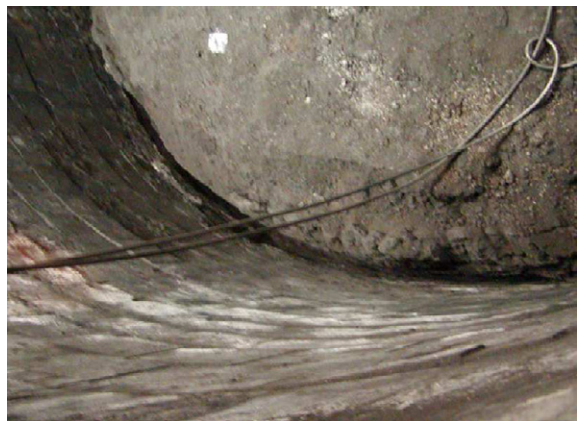
Fig. 3 View to BF3 trenched salamander

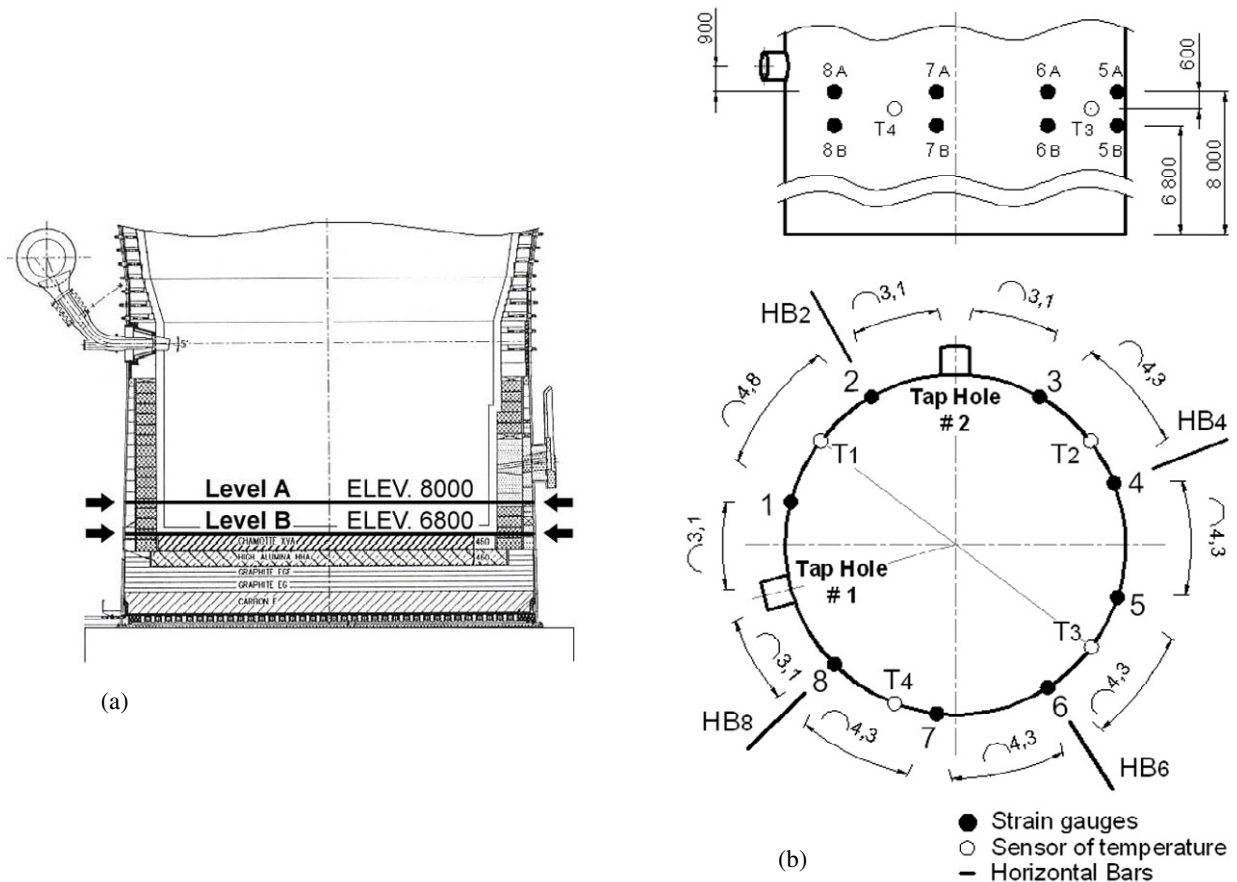
BF3 was blew down and quenched due to planned stack shotcrete outage, plate armor and refractory change. Also portal into the BF3 stack shell above tap hole # 1 was opened to clean up hearth, trench salamander and to build new blow-in line. Two rows of strain gauges were installed on both BF1 and BF3 hearth shells as presented on figure 4 [1], [5]. Each row contained 8 gauges. In addition to BF1 four horizontal bars, and one circumferential tape were installed on BF3 hearth.

Fig. 4 Two rows of strain gauges installed on both BF1 and BF3 hearth shells - (a) Strain gauges location on BF1 and BF3, (b) Sensors location on BF3 hearth shell

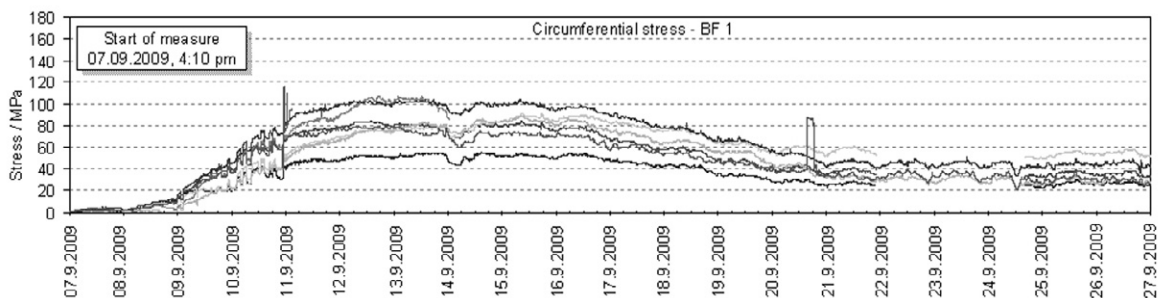
Before start up both furnaces furnaces were filled with standard blow in burden. Oxygen and natural gas fed tap hole burner was used in first period to heat up hearth and in the next step two tuyeres were opened above tap hole burner to start melting process. BF1 started with tap hole #1 and BF3 started with tap hole #2. On BF1, figure 5 the maximal tension 100 MPa was reached five days after start up.

Fig. 5 BF1 heart shell tension development measured by strain gauges

Maximal tension lasted four days and finally 14 days after start up shell tension, became stable on the range 20 – 40 MPa. Not uniform tension distribution through the shell circumference was detected. Maximal tension was measured on the opposite to tap hole #1, which was used for start up. Five hours outage caused approx. 10% BF shell tension drop. Gas and hydrostatic pressure contributed +10% to total stress increase.

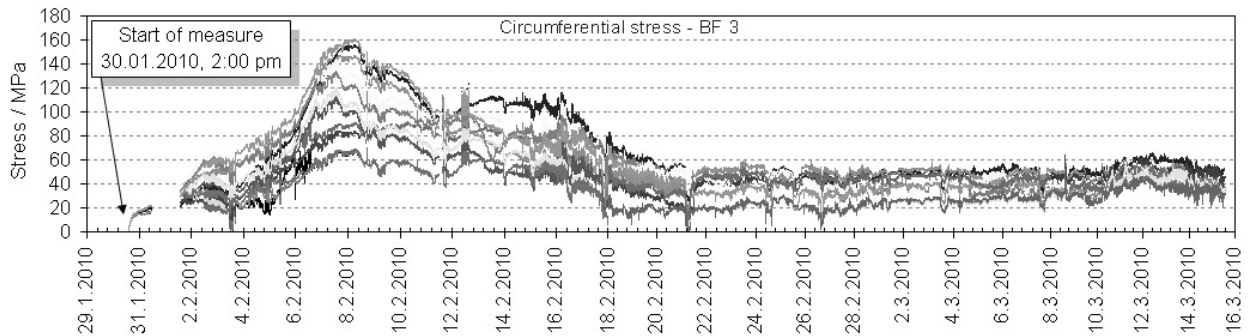
On BF3, Figure 6, the hearth shell tension 100 MPa was reached five days after start up. Next two days visible strong raise to maximal level 160 MPa. Maximal tension lasted one day and after next four days dropped to the level 100 MPa and finally after 18 days below 60 MPa and after 23 days to the range 30–50MPa.

Fig. 6 BF3 hearth shell tension measured by strain gauges

As visible from the figures 6 and 7 also not uniform tension distribution was also detected through the shell circumference. Measuring point #6 was on the opposite side to the tap hole #2, which was used for start up. Circumferential tape installed on BF3 hearth shell presented maximal stress 140 MPa.

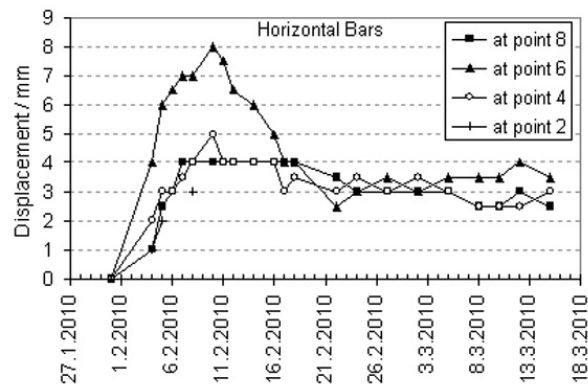
Fig. 7 BF3 horizontal bars displacement during the blow-in period.
